Inspection Report

123 Main Street
Melbourne FL 32901

Oasis Home Inspections, LLC

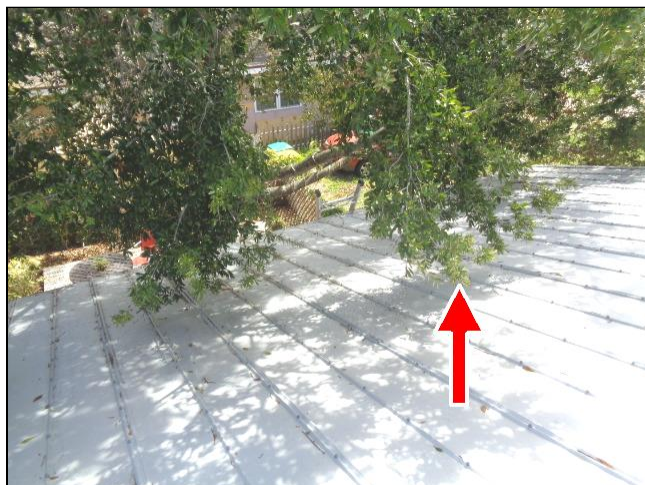
2.0 Item 1(Picture)

2.0 Roof Coverings
Condition: Repair or Replace

The tree limbs that are in contact with the roof or hanging near the roof should be trimmed.

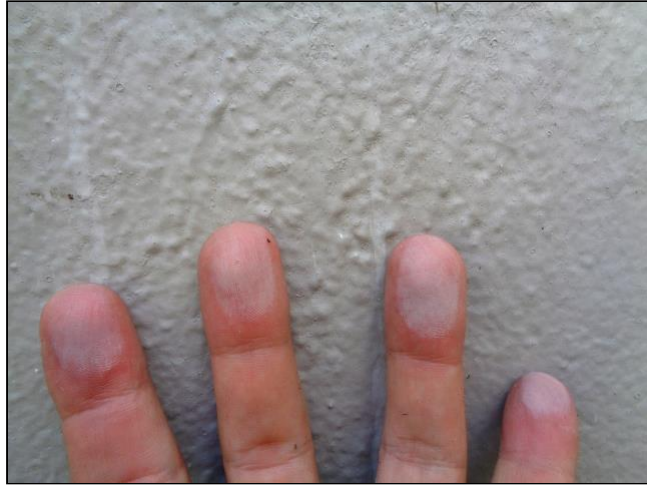
3.0 Item 1(Picture)

🔧 (1) Some fading paint, or paint that could be rubbed off by your hand was noted. This is a general indication that the exterior of the home may be due for paint in the near future.

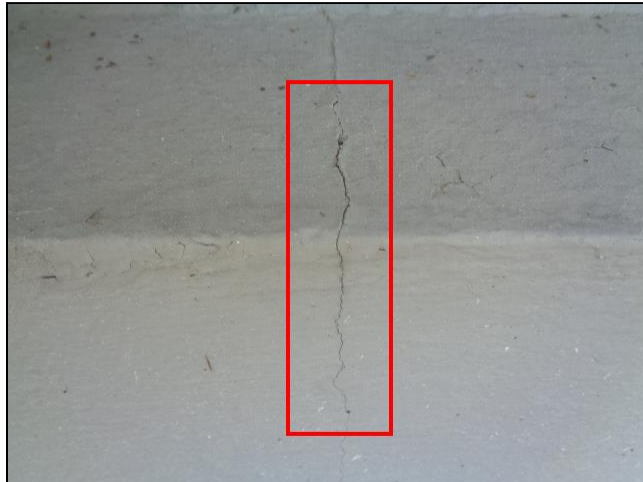
3.0 Item 2(Picture)

🔧 (2) Some minor cracking in the exterior stucco was noted on the exterior stucco in multiple areas around the home. Open cracks can allow for potential water entry, and cause hidden damage if left un-corrected. Areas where the wood framing meet the block, between levels is most important.

I recommend general repairs and maintenance to the exterior stucco. An exterior or siding professional can review and correct.

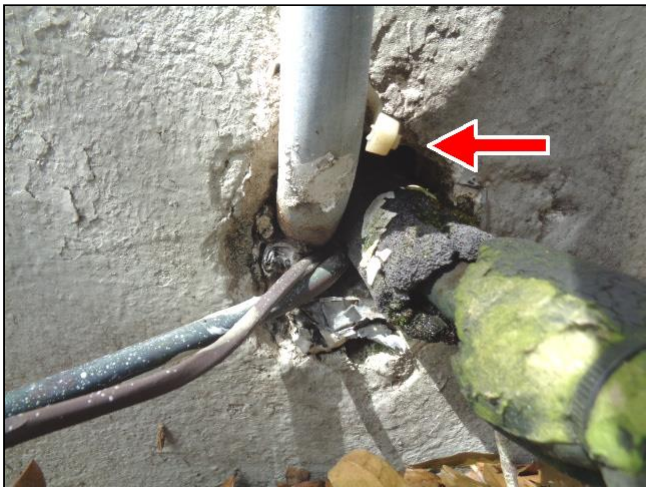
3.0 Item 4(Picture)

(3) The hole in block wall needs closing off with sealant or liquid foam at the rear of home where A/C compressor lines enter the home.

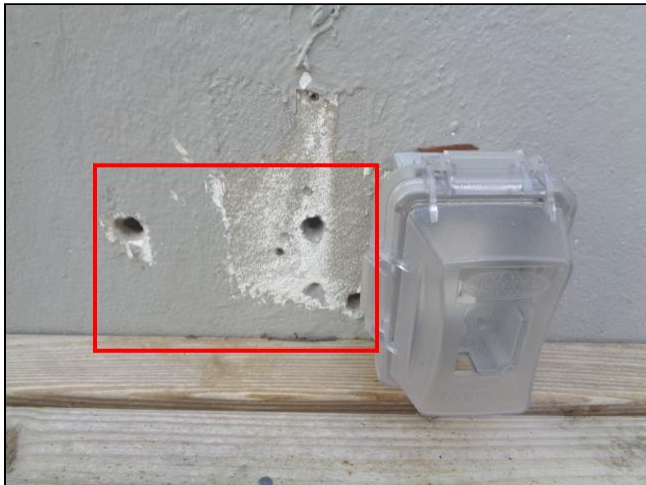
3.0 Item 5(Picture)

(4) The exterior has multiple open penetrations that need to be sealed and paint to prevent moisture intrusion into the home. Correct as needed.

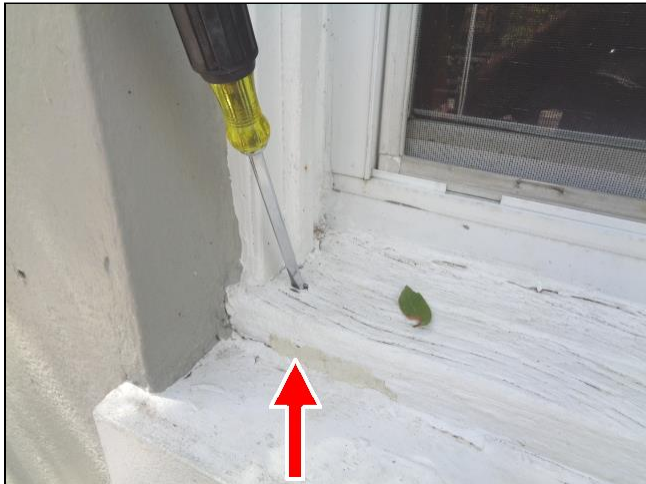
3.2 Item 1(Picture)

(2) Wood framed windows located at the rear had rot or moisture damage at the sills. Some past repairs were made with sealant or caulk and painted, but repairs performed will correct the problem and the wood will continue to deteriorate. All damaged wood should be replaced.

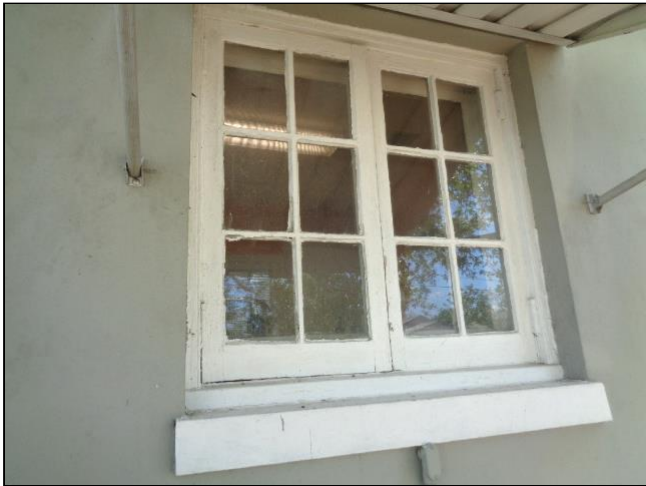
3.2 Item 3(Picture)

(3) Most of the windows in the home are single pane glass. These windows are outdated and can allow greater energy loss than modern windows. You should consider upgrading these in the future.

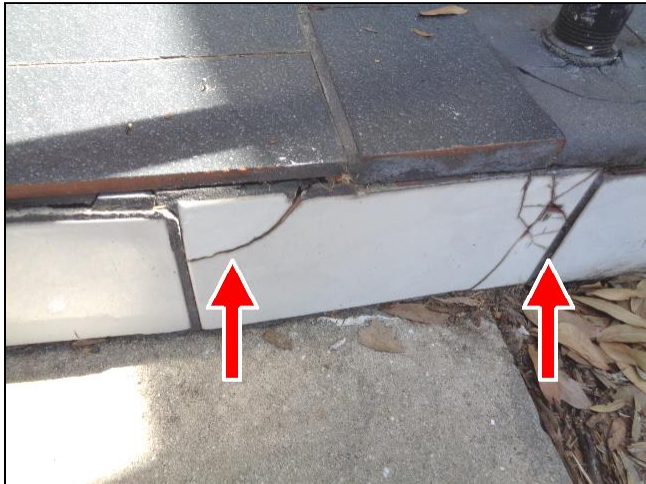
3.3 Item 1(Picture)

The tile on the covered front porch and steps are cracked and failing. Further deterioration will occur if not repaired. Repair or replace as needed.

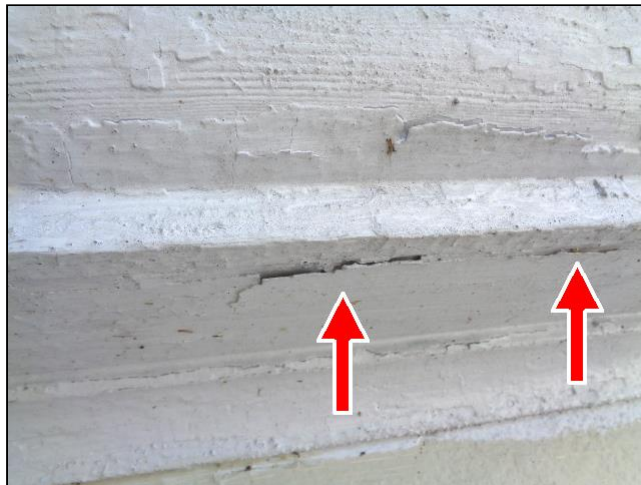
3.5 Item 1(Picture)

🔧 The paint on eaves is failing.
Recommend prep and paint affected
areas.

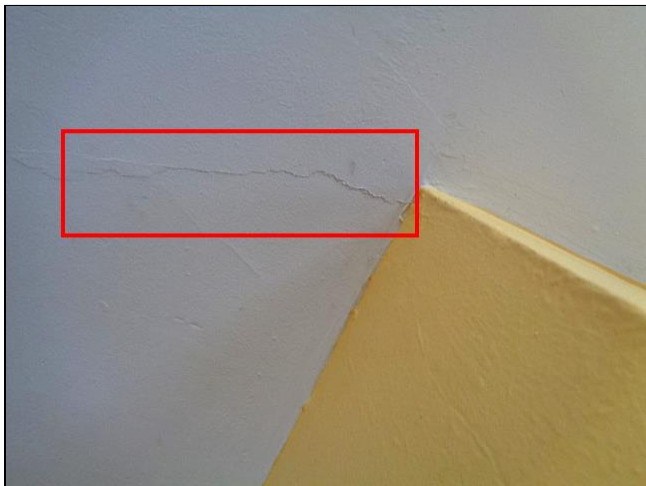
4.1 Item 1(Picture)

The ceiling at the end of hall reveals hairline cracks either from paper tape missing at the seams or from settlement. This is not a load bearing location so this appears to be cosmetic. I recommend a qualified finisher correct as needed.

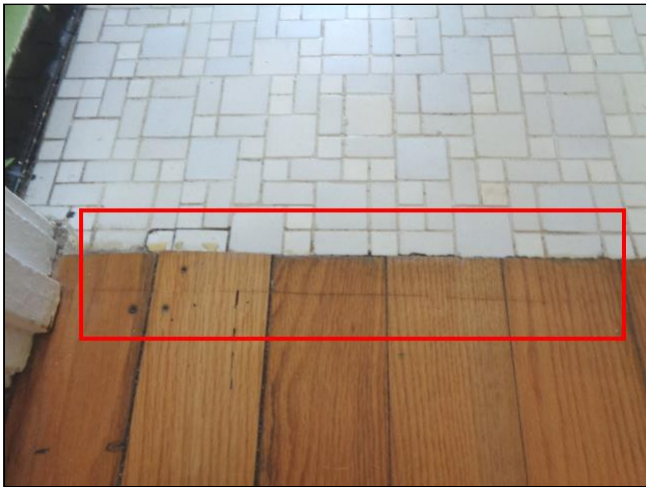
4.3 Item 1(Picture)

The transition strip is missing on the entry to the hall bathroom. Correct as needed.

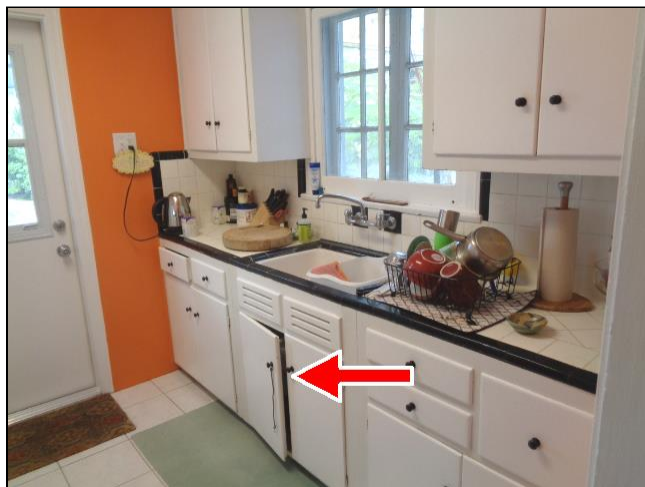
4.5 Item 1(Picture)

Some cabinet doors need magnets or securing hardware to stay shut. Correct as needed.

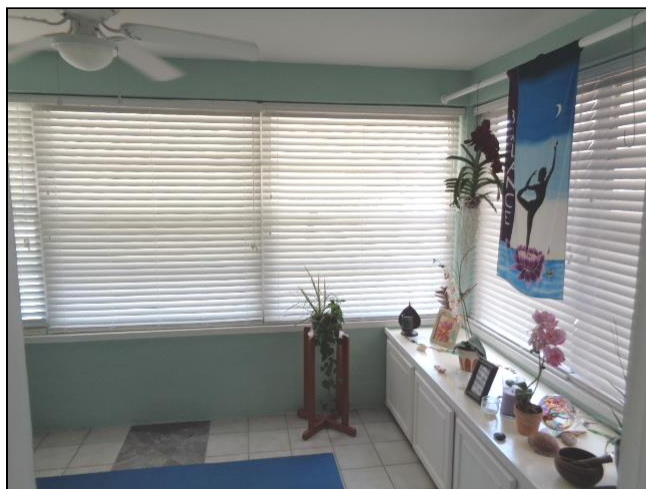
5.6 Item 1(Picture)

🔍 The home appeared to have a previous sun room or porch enclosed for living purposes. It is recommended that you check to ensure proper permitting was obtained for the enclosure. Un-permitted additions may not have proper structural features, or hidden issues. Any un-permitted structures could include retroactive fines, or require costly updates/improvements to meet modern compliance by the municipality. I disclaim any un-permitted structure in its entirety, and am not liable for hidden or concealed defects.

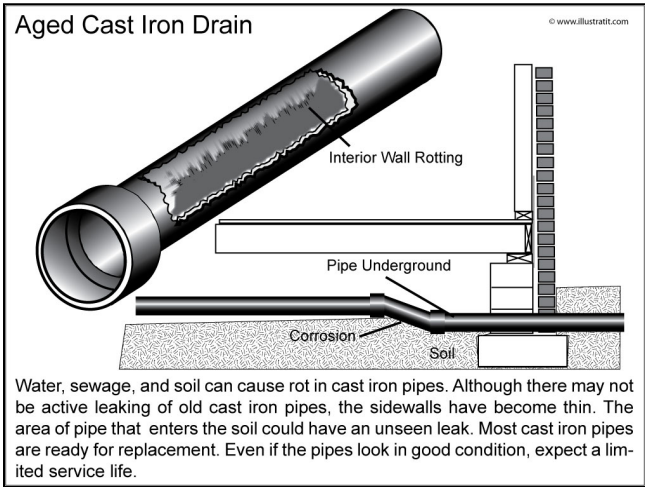
6.1 Item 1(Picture)

Some of the visible drain pipe was made of cast iron, which was the standard pipe used for older homes. Cast iron pipe has a general service life of 50 years, and can begin to deteriorate or rust through when it becomes aged. Since some visible Cast Iron pipe exists, I suspect that some cast iron may also be present under the slab.

I recommend you consider having a lateral sewer inspection performed of the drain pipe. A lateral sewer camera inspection can internally evaluate the integrity of the piping to ensure it is not deteriorated and is in need of replacing. A plumbing contractor that performs this service can review and advise.

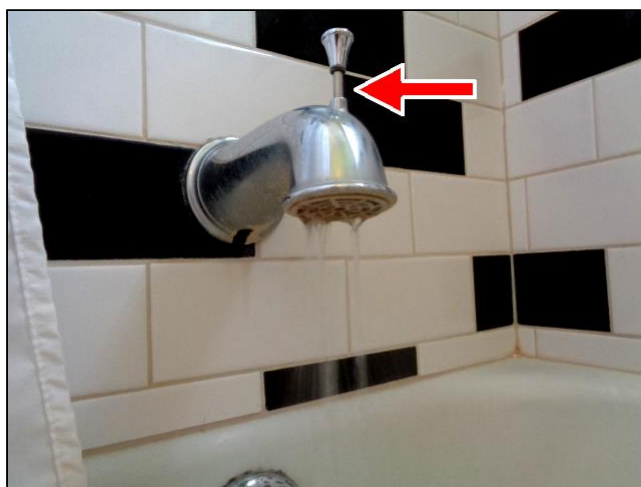
6.2 Item 1(Picture)

🔧 (1) The tub spout diverter leaks in the master bath. Repairs are needed. A plumber should correct as needed.

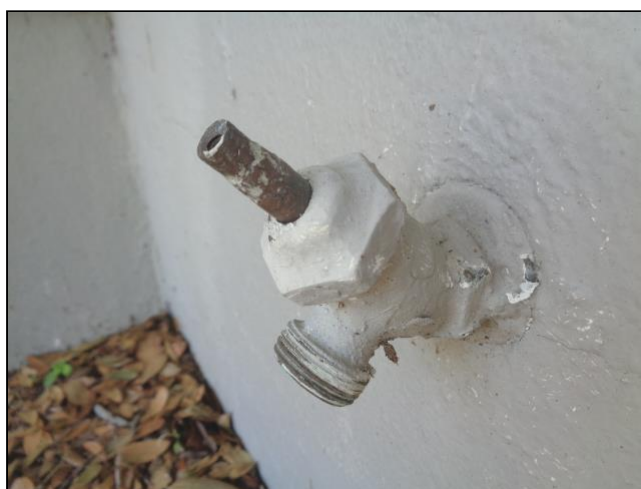
6.2 Item 2(Picture)

🔧 (2) The knob for hose bib is missing at the rear of home. Repairs are needed.

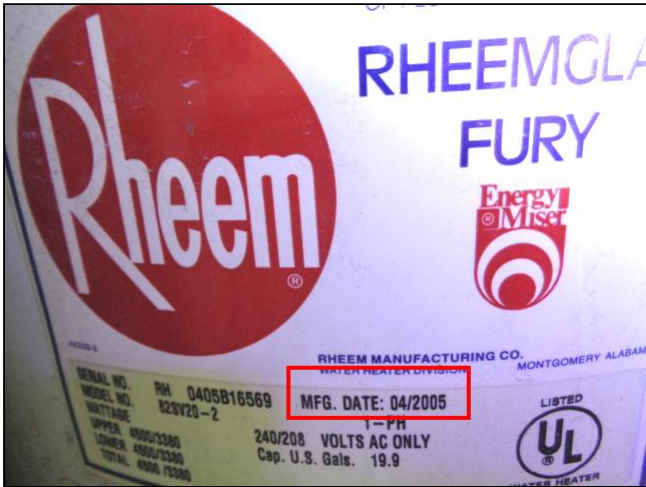
6.3 Item 1(Picture)

✚ (1) The water heater has past its expected service life. It was functioning properly at the time of the inspection, but should be monitored for leaks due to age. A replacement should also be considered.

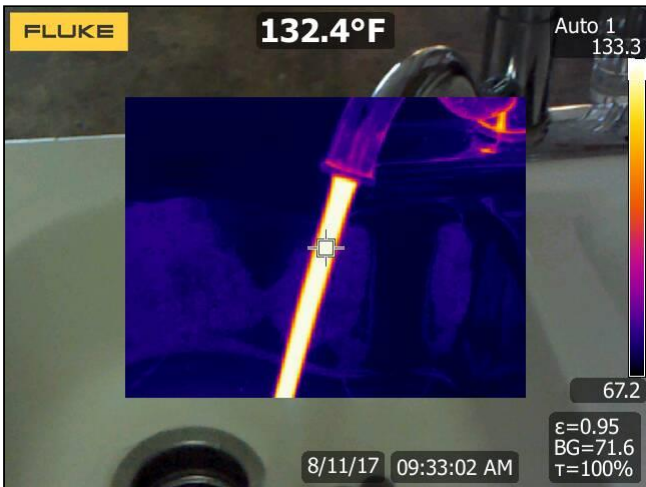
6.3 Item 2(Picture)

(2) The photo shows hot water being produced at a sink location, indicating the water heater did function at the time of the inspection.

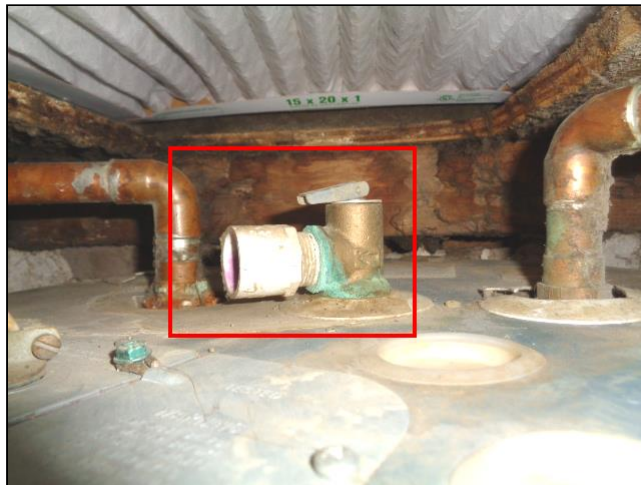
6.3 Item 3(Picture)

🔧 (3) The Temperature and Pressure Relief Valve on water heater needs a 3/4" threaded pipe to extend within 6 inches of floor for safety. (PVC is not approved for hot water use). The pipe directs hot water to the ground in the event of the valve opening.

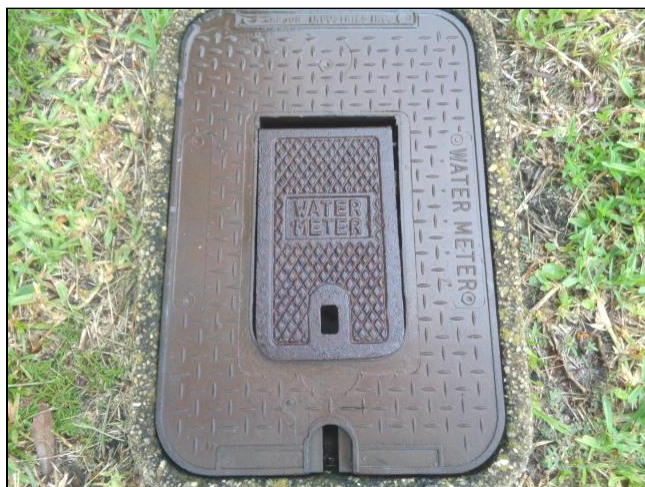
6.4 Item 1(Picture)

Image shows the main water shut-off location. Outside with the service meter.

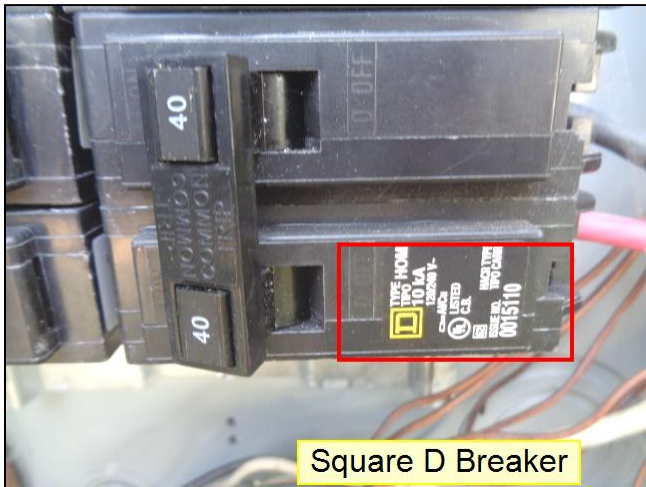
7.3 Item 1(Picture)

Three circuit breaker in main panel are a different brand than panel manufacturer. Use of mismatched or non-approved breakers will void the warranty and may cause electrical issues in the panel. I advise you have an electrician review the panel and replace any non-compliant breakers.

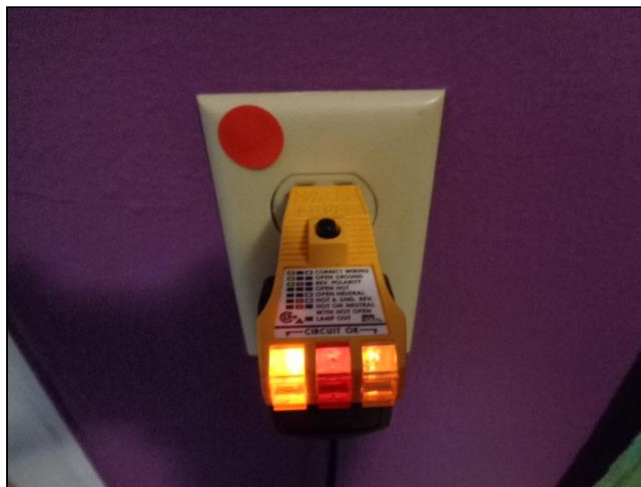
7.4 Item 1(Picture)

🔌 (1) Outlet or outlets, in the master bedroom marked with a RED dot sticker, tested for reverse polarity or may be wired backwards . Correct as needed.

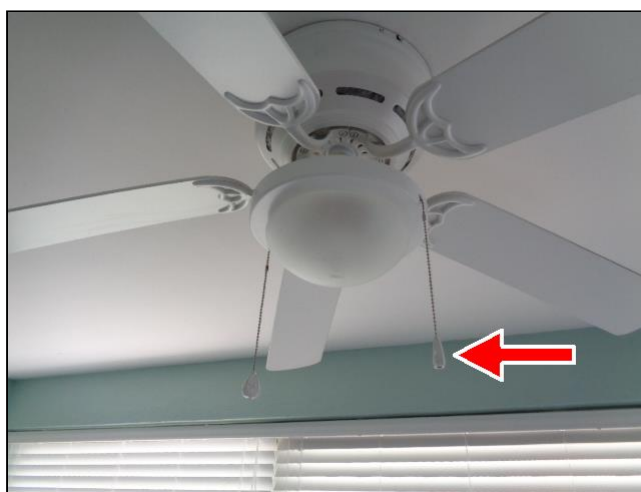
7.4 Item 2(Picture)

(2) The ceiling fan is controlled by a pull chain only in the sun room. This is for your information.

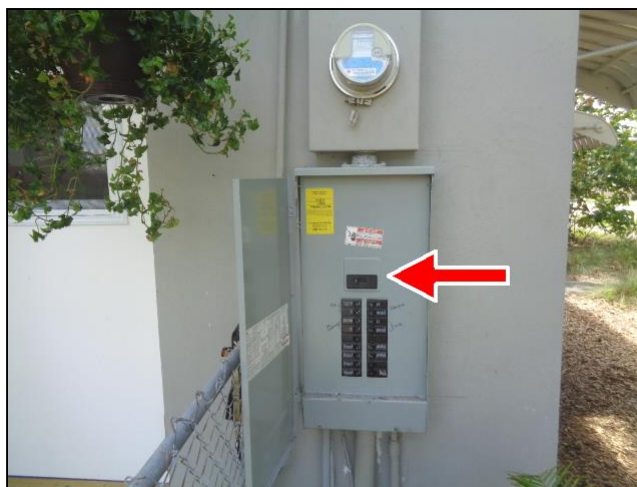
7.8 Item 1(Picture)

The main electrical panel is located in the outside.

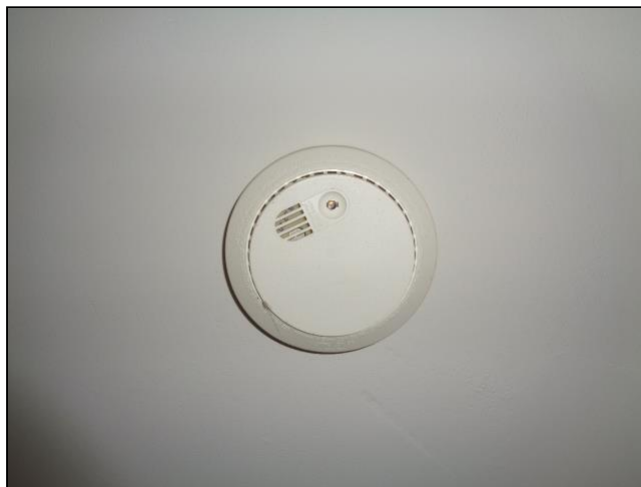
7.9 Item 1(Picture)

🔧 The smoke detectors in the home are over 10 years of age. The NFPA (National Fire Protection Association) recommends replacing smoke detectors every 10 years to ensure safe operation. Replacing all detectors in the home is recommended for safety reasons.

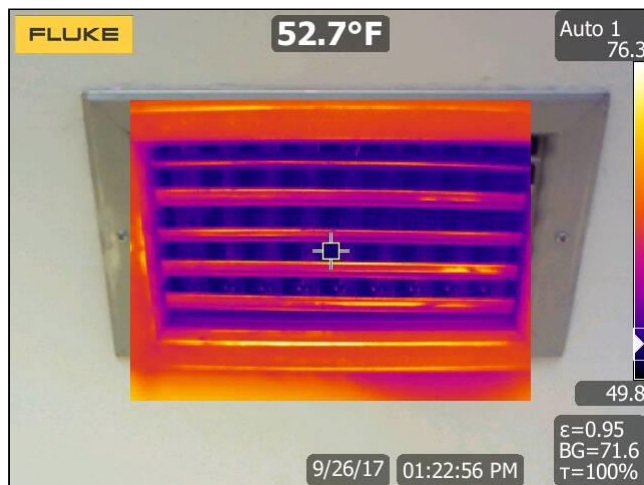
8.1 Item 1(Picture)

(1) The A/C was working but was at or beyond general service life. General service life for a A/C unit is 10 to 15 years, depending on several factors. Recommend having the unit cleaned and serviced by a licensed person, and also plan on replacement in the future. I cannot guarantee or estimate service life remaining.

(2) Thermal image of the A/C system functioning.

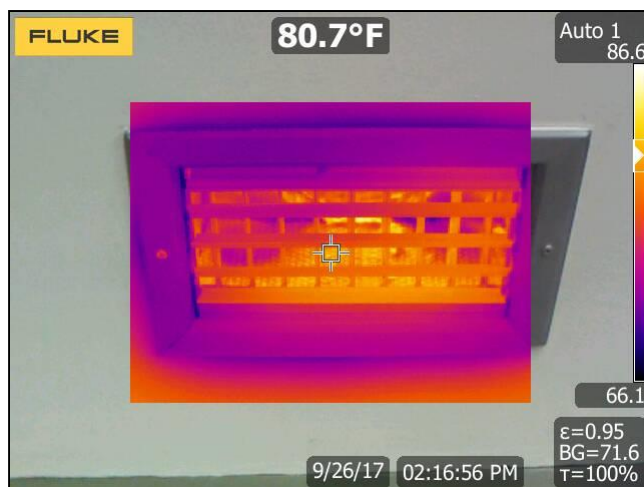
8.2 Item 1(Picture)

(1) The heating unit was considered past its expected service life. It did operate during the inspection but should be serviced and cleaned. Service by an HVAC person, before you obtain the property can determine repairs or replacement needs that are beyond the scope of a home inspection, such as evaluation of the heat exchanger.

(2) Thermal image of the heating system functioning.

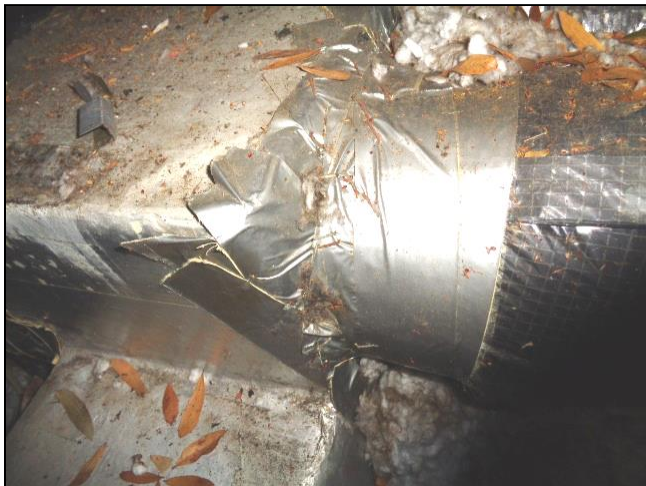
8.3 Item 1(Picture)

separation or loss of conditioned air into the attic. Some amateur repairs where made using (Duck Tape) instead of foil duct tape.

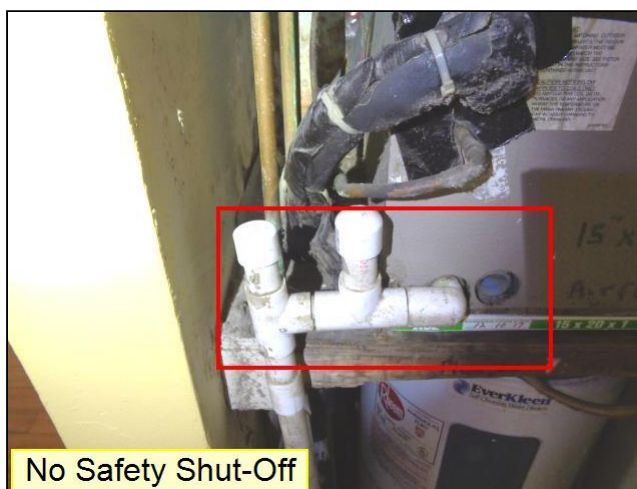
8.4 Item 1(Picture)

🔧 An in-line condensate shut off was not installed on the unit. The application of this can prevent water damage to the home in the event the condensation drain line becomes clogged. It is recommended you have one retrofitted to prevent potential water damage in the future. An hvac contractor can correct.

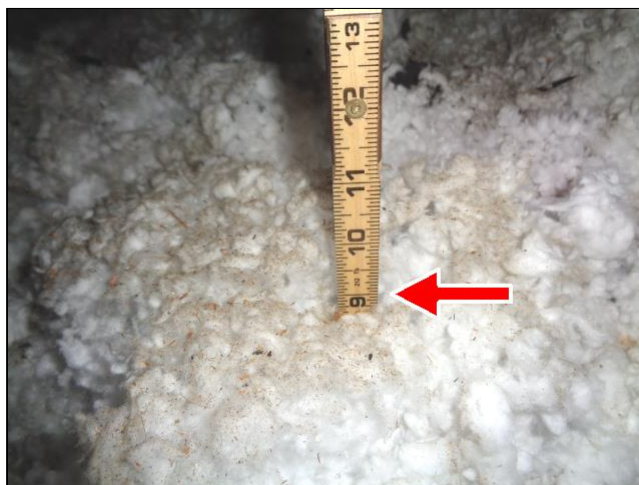
9.0 Item 1(Picture)

One inch of insulation roughly has a R-Value of 3.5 in most residential applications. The R-Value varies slightly depending on the type of insulation used. Currently the Florida Building Code requires a minimum of R-30 in residential attics. 9 inches of insulation approximately R-31.5 was visible in the attic.

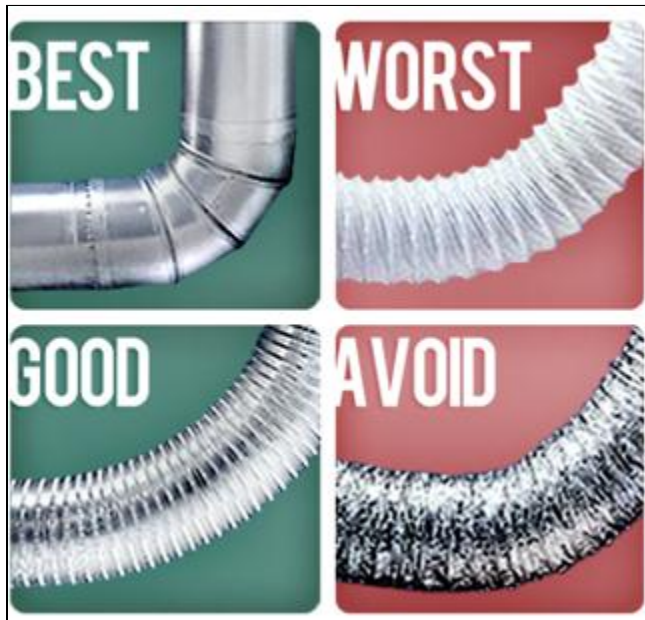
9.4 Item 1(Picture)

🔧 (1) The dryer vent is a plastic or foil accordion style vent material, prone to clogs and tears. Due to fire hazards reported with this style of vent, I suggest replacing it with a rigid or corrugated semi-rigid metal duct. Most dryer manufacturers specify the use of a rigid or corrugated semi-rigid metal duct, which provides maximum airflow.

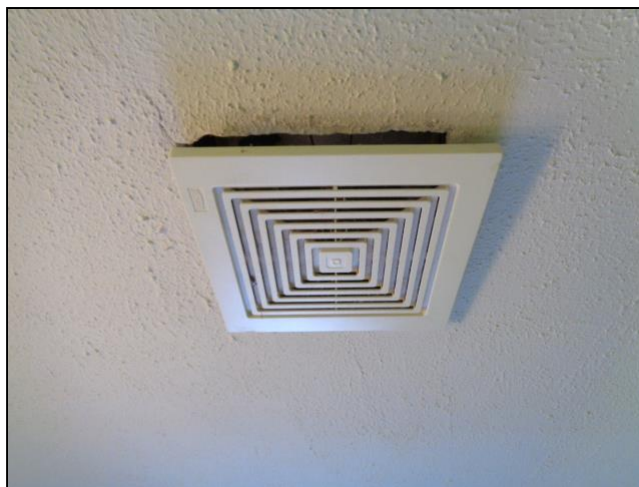
9.4 Item 3(Picture)

🔧 (2) The Exhaust fan is loose and not securely mounted at the master bath. Repair or replace as needed.

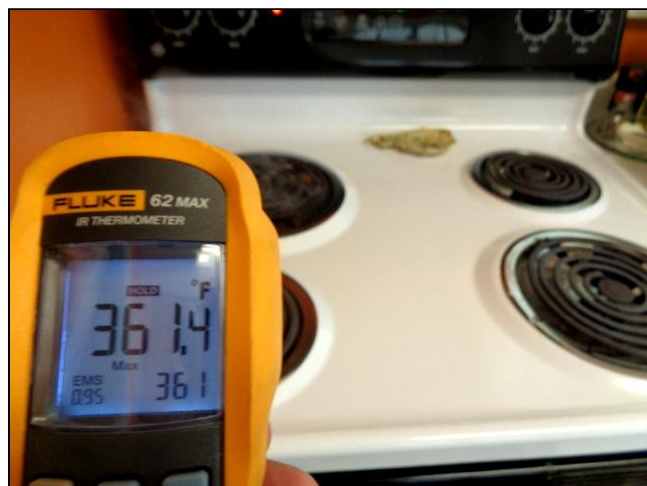
10.2 Item 2(Picture)

(2) Picture(s) of operating range / ovens / cooktops.

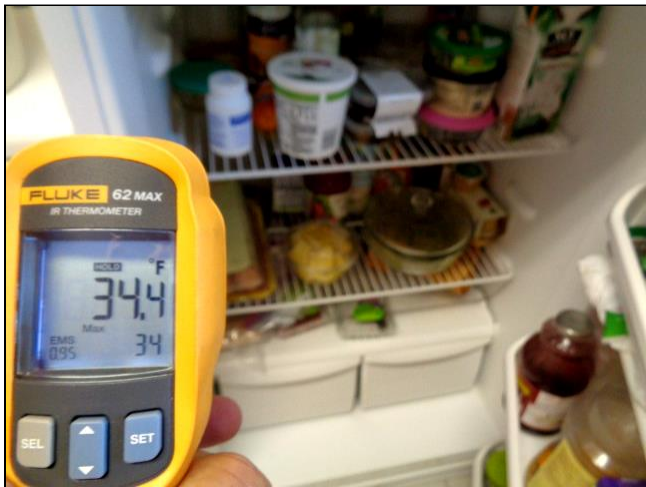
10.6 Item 1(Picture)

Pictures of temperature readings for the refrigerator and freezer.
